PA Turnpike E-Ticketing

Pennsylvania Turnpike – Asphalt Stripping

**Asphalt Stripping
PA Turnpike Mainline
MP 54 to MP 282**

Asphalt Stripping Research Results

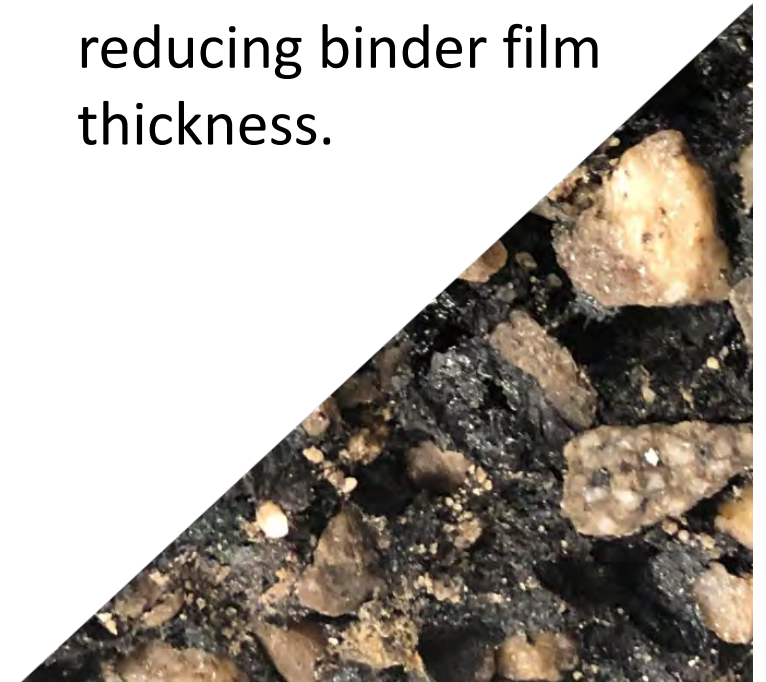
PENNSYLVANIA TURNPIKE (CUMBERLAND COUNTY)

Typical telltale signs of moisture-induced stripping: fines brought up to the surface by water (mud stains), flushing of the surface, and potholing, were clearly visible on the W.B. slow lane from MP 215.5 to 218.0 (Figure 1). Potholes had developed in both wheel tracks of the W.B. slow lane between MP 215.5 and 218.0. There were more potholes in the inside wheel track compared to the outside wheel track (Figure 2). ~~Rutting of the pavement had also started to develop in many areas (Figure 3). A similar investigation of an adjacent section of the Pennsylvania Turnpike between MP 218 and 226 was conducted by the first author in 1978 (1). On that project, the potholing was primarily occurring in the inside wheel track of the slow lane and rutting associated with stripping was not a significant problem. Therefore, this project was exhibiting more severe distressed condition than the 1978 project.~~

MP 215.5 to MP 218.0

WB RL

Paved 1994

Stripping Noted 1996

Pennsylvania Turnpike Mile Post (MP) 209.5 to 218.0 received an asphalt overlay consisting of 37 mm thick ID-2 wearing course (it is a dense-graded 9.5 mm nominal size mix) in 1994. The percentage of material passing 4.75, 2.36, and 0.075 mm was 71, 45, and 4.5 percent, respectively, with a design asphalt content of 6.3 percent. ~~The overlay consisting of crushed gravel aggregate HMA mixture was placed during the period of April-November 1994 after milling the existing road surface to an average depth of 40 mm. This project started to exhibit premature pavement distress in 1996 primarily on the westbound (W.B.) slow lane from MP 215.5 to 218.0.~~ The section from MP 209.5 to 215.5 did not develop any significant pavement distress. The project was inspected in July 1996 to investigate the probable cause of the distress. The following observations were recorded during the inspection.

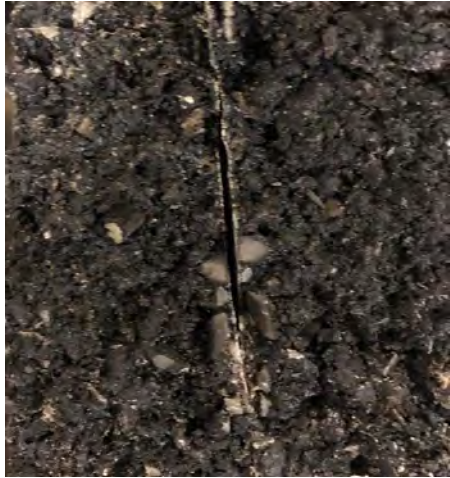
No Stripping

In 2019, PTC Materials Laboratory had identified many occurrences of severe asphalt stripping while performing, non-related, research. Core specimens were obtained from various pavement locations; tested and analyzed. Stripping had been observed within core specimens obtained between milepost 54 and 282.

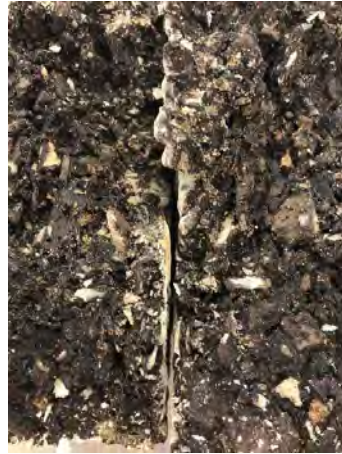
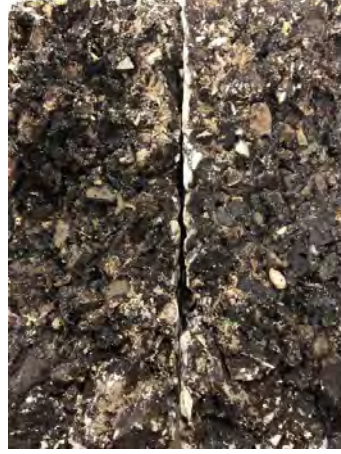
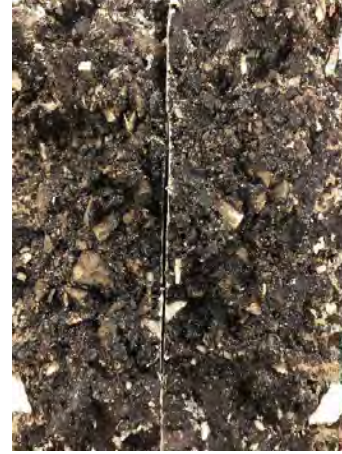
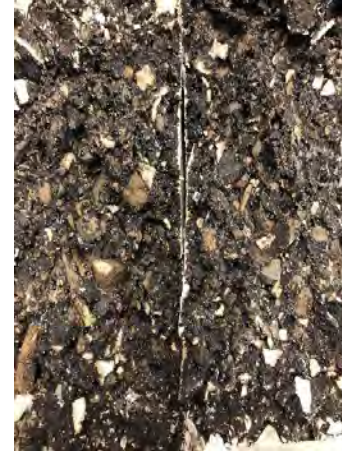
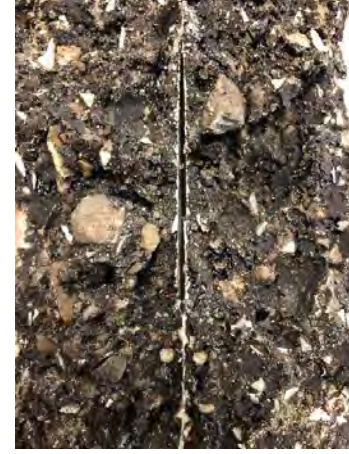
MP 49 to MP 56

Beginning Milepost:	49
Ending Milepost:	56
Recently Paved:	2010
Geological Makeup:	CSS
Asphalt Supplier:	Marathon
Asphalt Grade:	76-22
Anti-Strip Supplier:	NG
Anti-Strip %:	NG
TSR Value:	95.6
Type of Distress: Raveling and Cracking

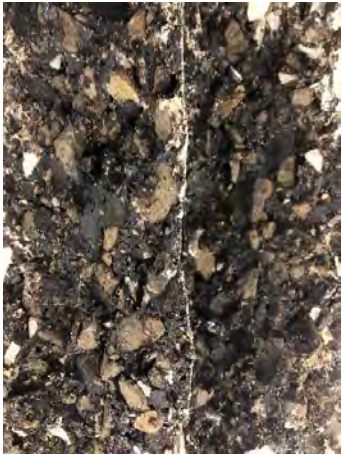
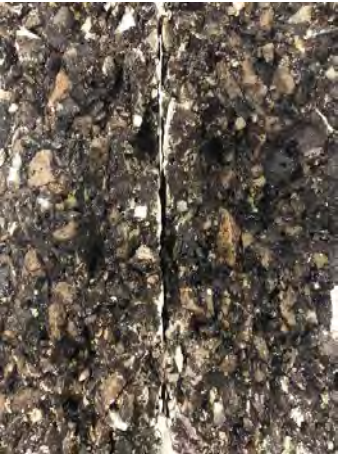
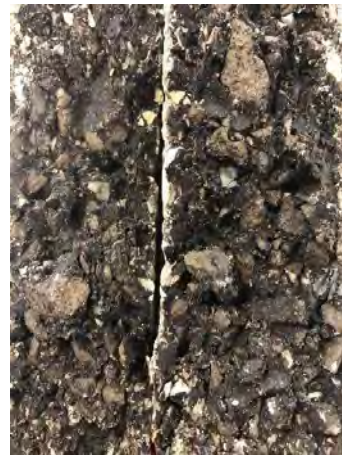
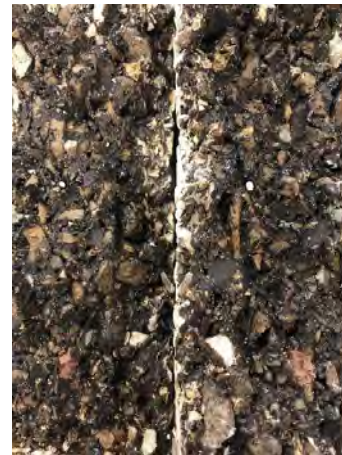
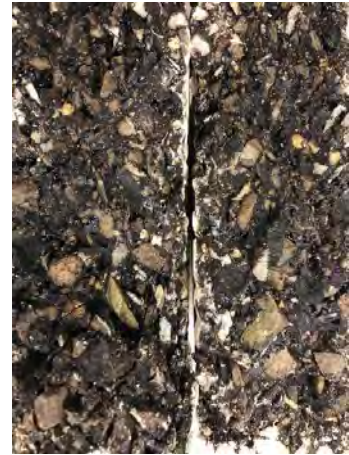
MP 94 to MP 99

Beginning Milepost:	94
Ending Milepost:	99
Recently Paved:	2012
Geological Makeup:	CSS
Asphalt Supplier:	Marathon
Asphalt Grade:	76-22
Anti-Strip Supplier:	ARR-MAZ
Anti-Strip %:	0.25
TSR Value:	83.2
Type of Distress: Raveling and Cracking

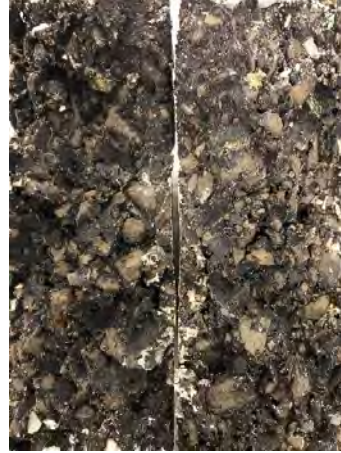
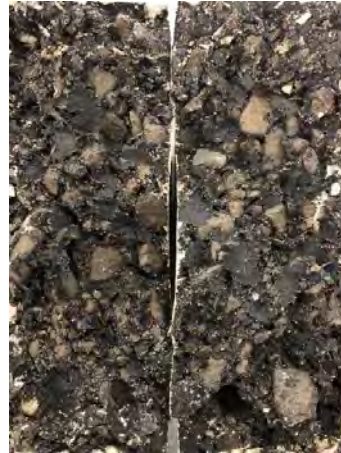
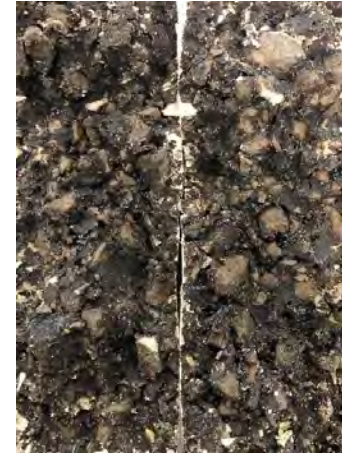
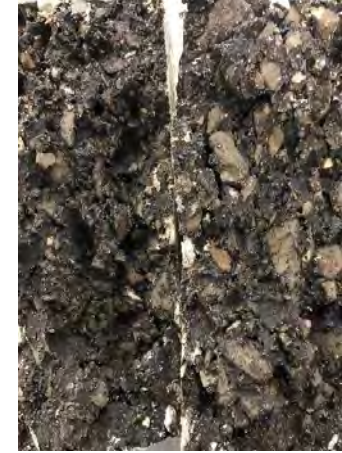
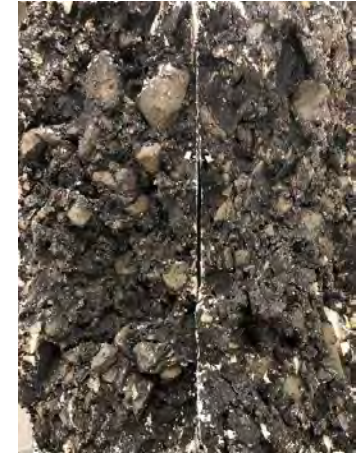
MP 180 to MP 184

Beginning Milepost:	180
Ending Milepost:	184
Recently Paved:	2011
Geological Makeup:	CSS
Asphalt Supplier:	Nustar
Asphalt Grade:	76-22
Anti-Strip Supplier:	NG
Anti-Strip %:	NG
TSR Value:	NG
Type of Distress: Raveling and Cracking

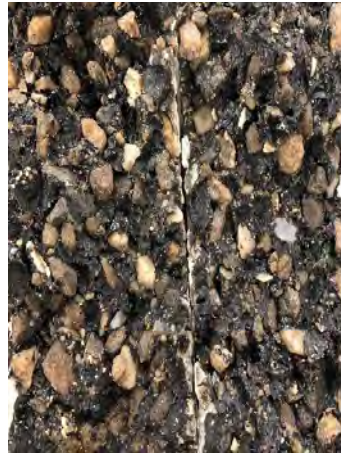
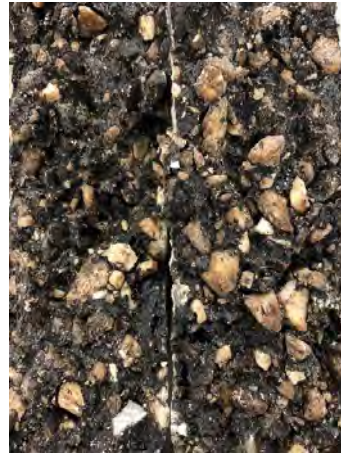
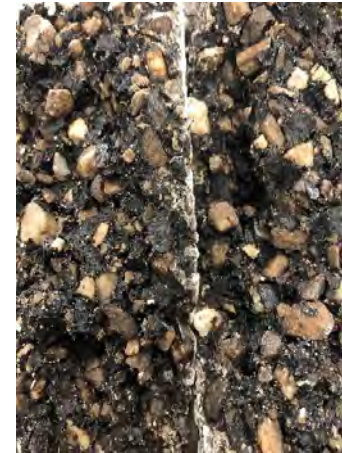
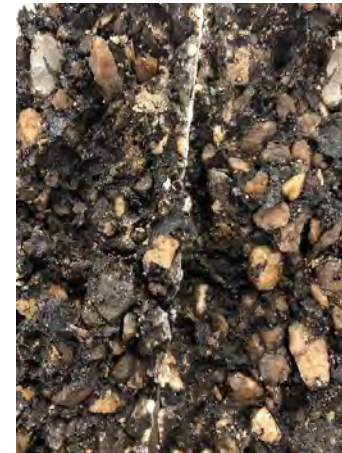
MP 205 to MP 206

Beginning Milepost:	205
Ending Milepost:	206
Recently Paved:	2018
Geological Makeup:	QZ
Asphalt Supplier:	Associated
Asphalt Grade:	76-22
Anti-Strip Supplier:	AD-HERE
Anti-Strip %:	0.5
TSR Value:	98.6
Type of Distress: Rutting

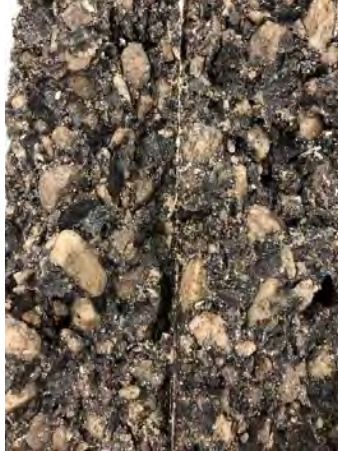
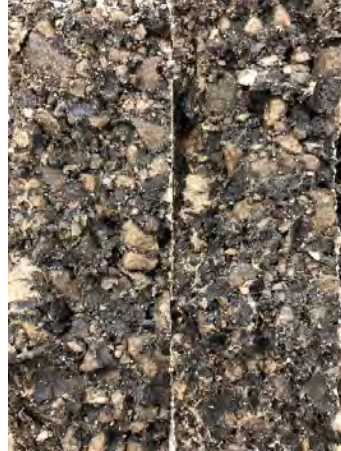
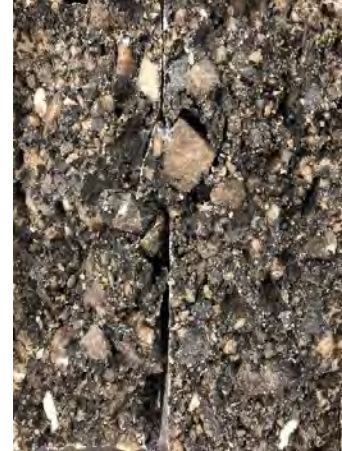
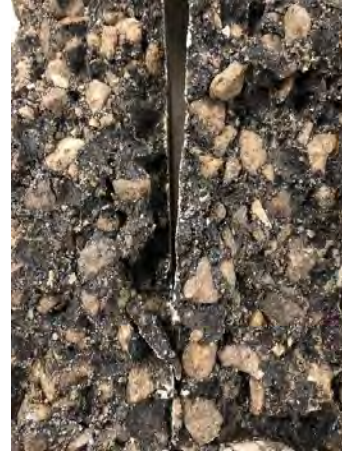
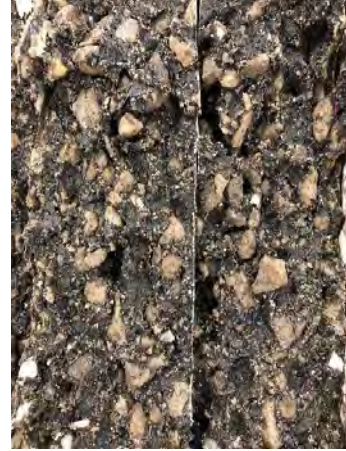
MP 215 to MP 220

Beginning Milepost:	215
Ending Milepost:	220
Recently Paved:	2011
Geological Makeup:	QZ
Asphalt Supplier:	Bitnumar
Asphalt Grade:	76-22
Anti-Strip Supplier:	Pave-Grip
Anti-Strip %:	0.5
TSR Value:	99.5
Type of Distress:	
Rutting

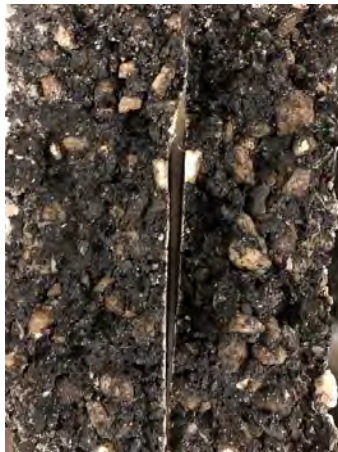
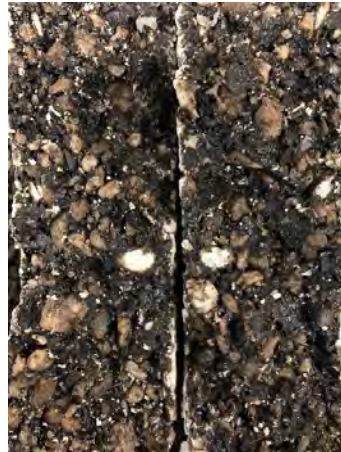
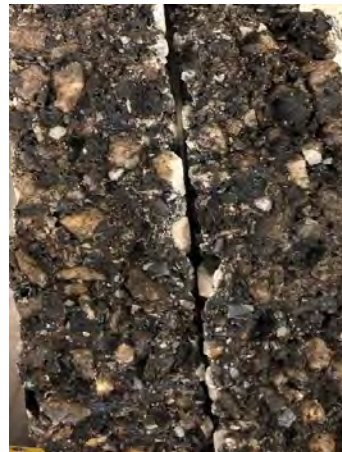
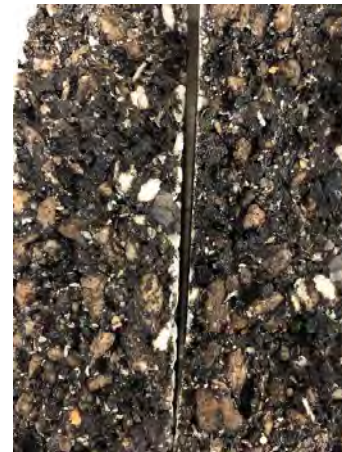
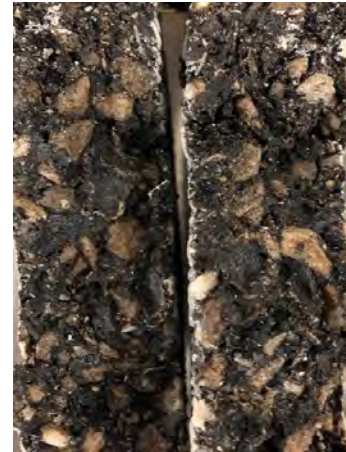
MP 236 to MP 241

Beginning Milepost:	236
Ending Milepost:	241
Recently Paved:	2016
Geological Makeup:	QZ
Asphalt Supplier:	Axon
Asphalt Grade:	76-22
Anti-Strip Supplier:	Evotherm
Anti-Strip %:	0.25
TSR Value:	94.6
Type of Distress:	
Raveling and Cracking

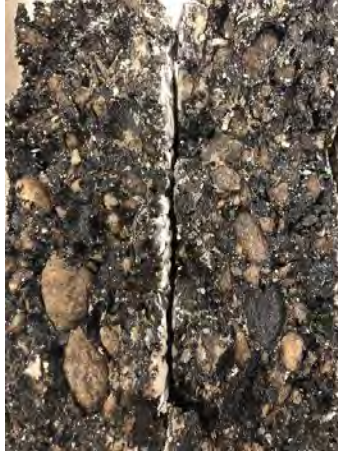
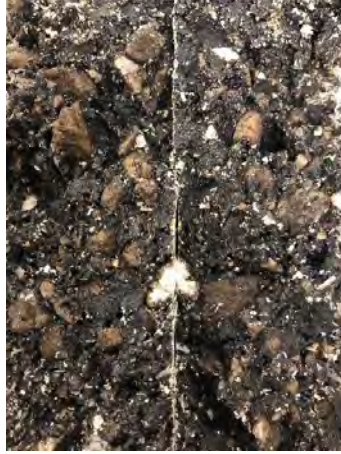
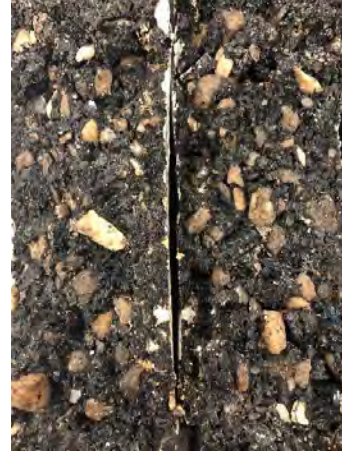
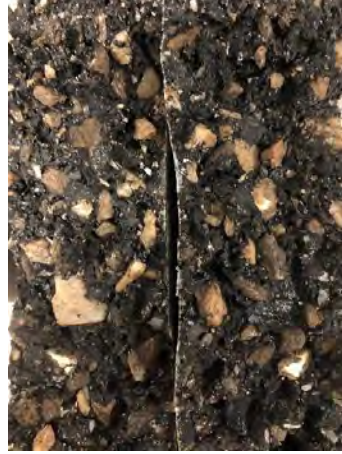
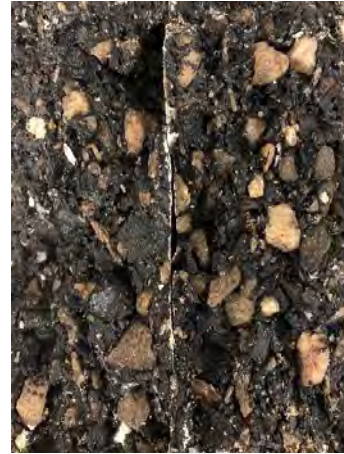
MP 247 to MP 255

Beginning Milepost:	247
Ending Milepost:	255
Recently Paved:	2011
Geological Makeup:	QZ
Asphalt Supplier:	Associated
Asphalt Grade:	76-22
Anti-Strip Supplier:	AD-HERE
Anti-Strip %:	0.25
TSR Value:	93.5
Type of Distress: Raveling and Cracking

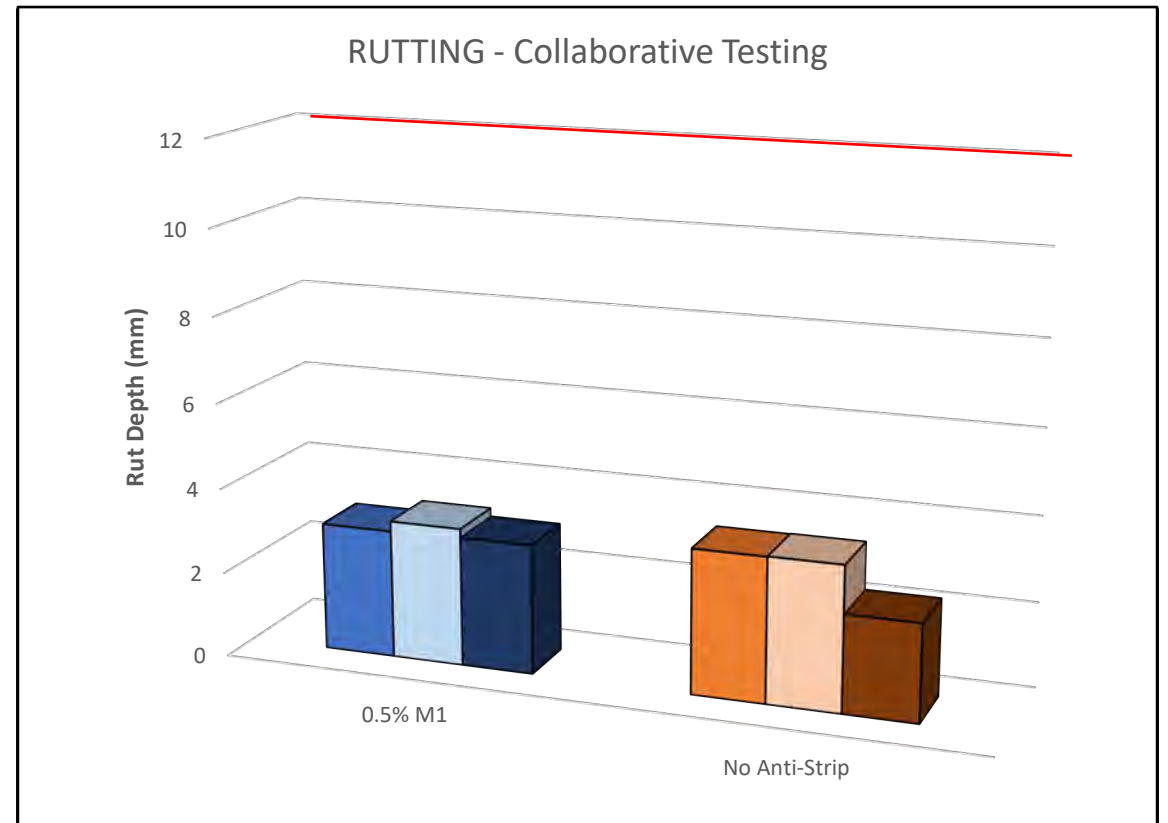
Hamburg: Collaborative Testing

0.5% Anti-Strip

PTC Lab Sample : Rut Depth = **3.01 mm**

Ingevity Sample : Rut Depth = **3.25 mm**

Penn State Sample : Rut Depth = **3.05 mm**

Without Anti-Strip

PTC Lab Sample : Rut Depth = **3.39 mm**

Penn State Sample : Rut Depth = **2.29 mm**

❖ No Stripping Inflection Point

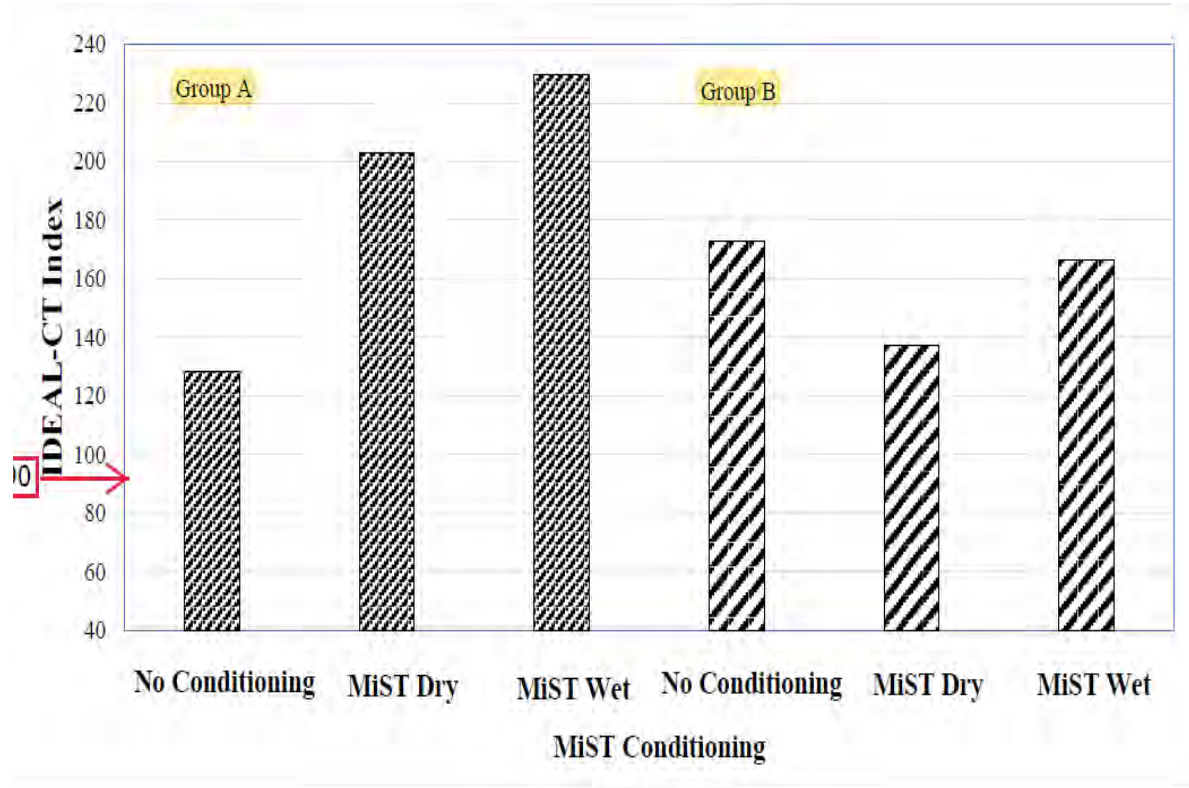
Penn State – M.I.S.T Results

Group A

- ❑ Increased in CT-Index after being subjected to the conditioning cycle. The increase is believed to be caused by damage induced by the conditioning which weakens the mix.

Group B

- ❑ CT-Index relatively more stable.

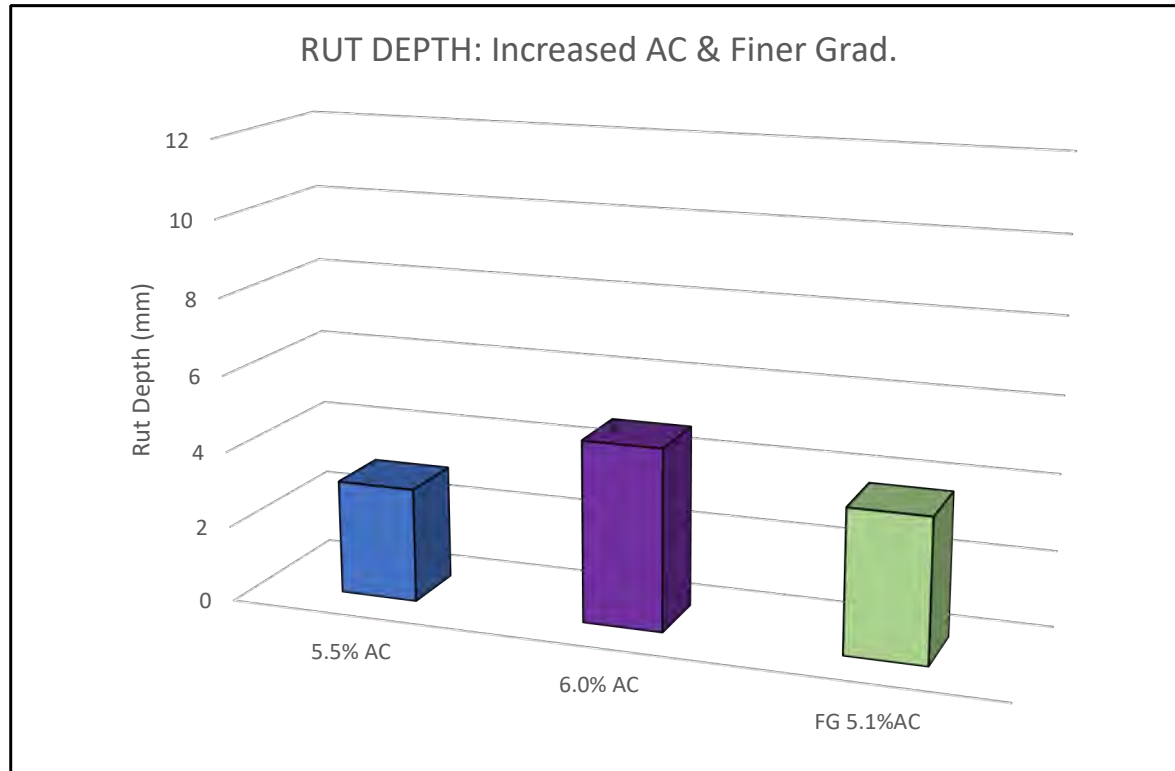
Hamburg: Design vs +0.5%AC vs Fine Grade -0.4%AC

Des. @ 5.5% AC

Des. @ 6.0% AC

Fine @ 5.1% AC

3.01

4.77

3.77

❖ No Stripping Inflection Point

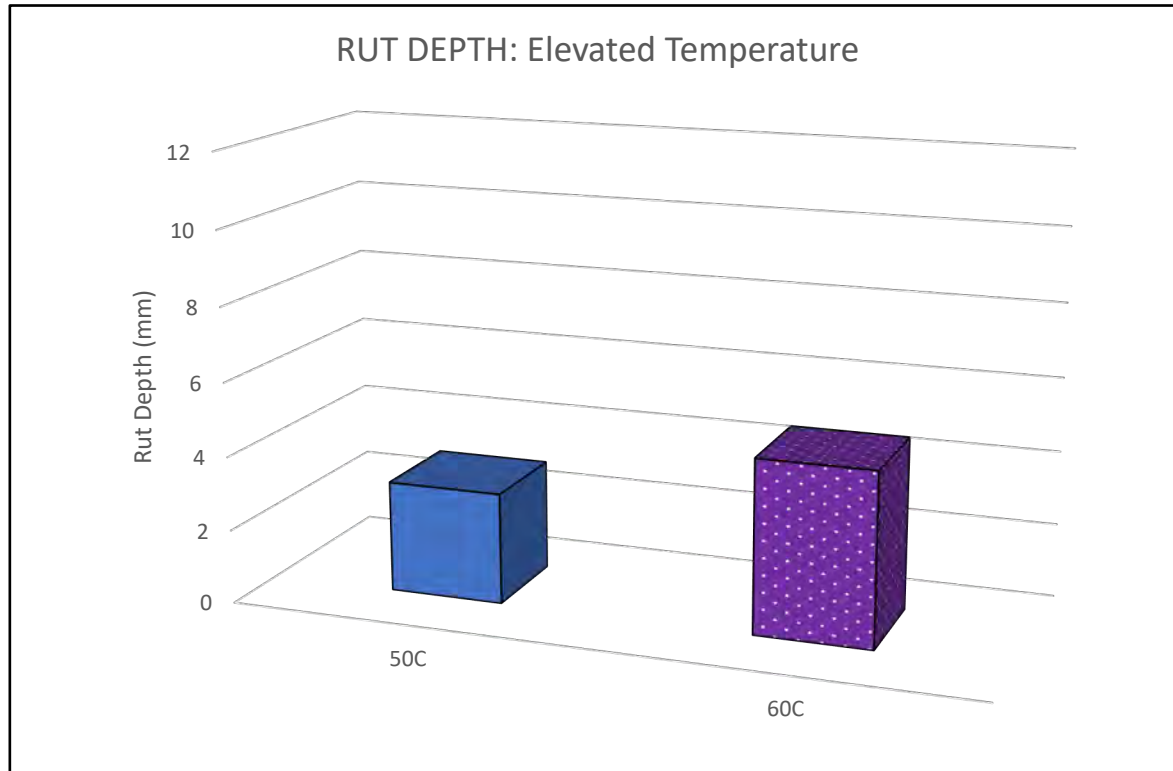
Hamburg: Elevated Testing Temperature

Tested @ 50°C

3.01

Tested @ 60°C

4.69

❖ No Stripping Inflection Point

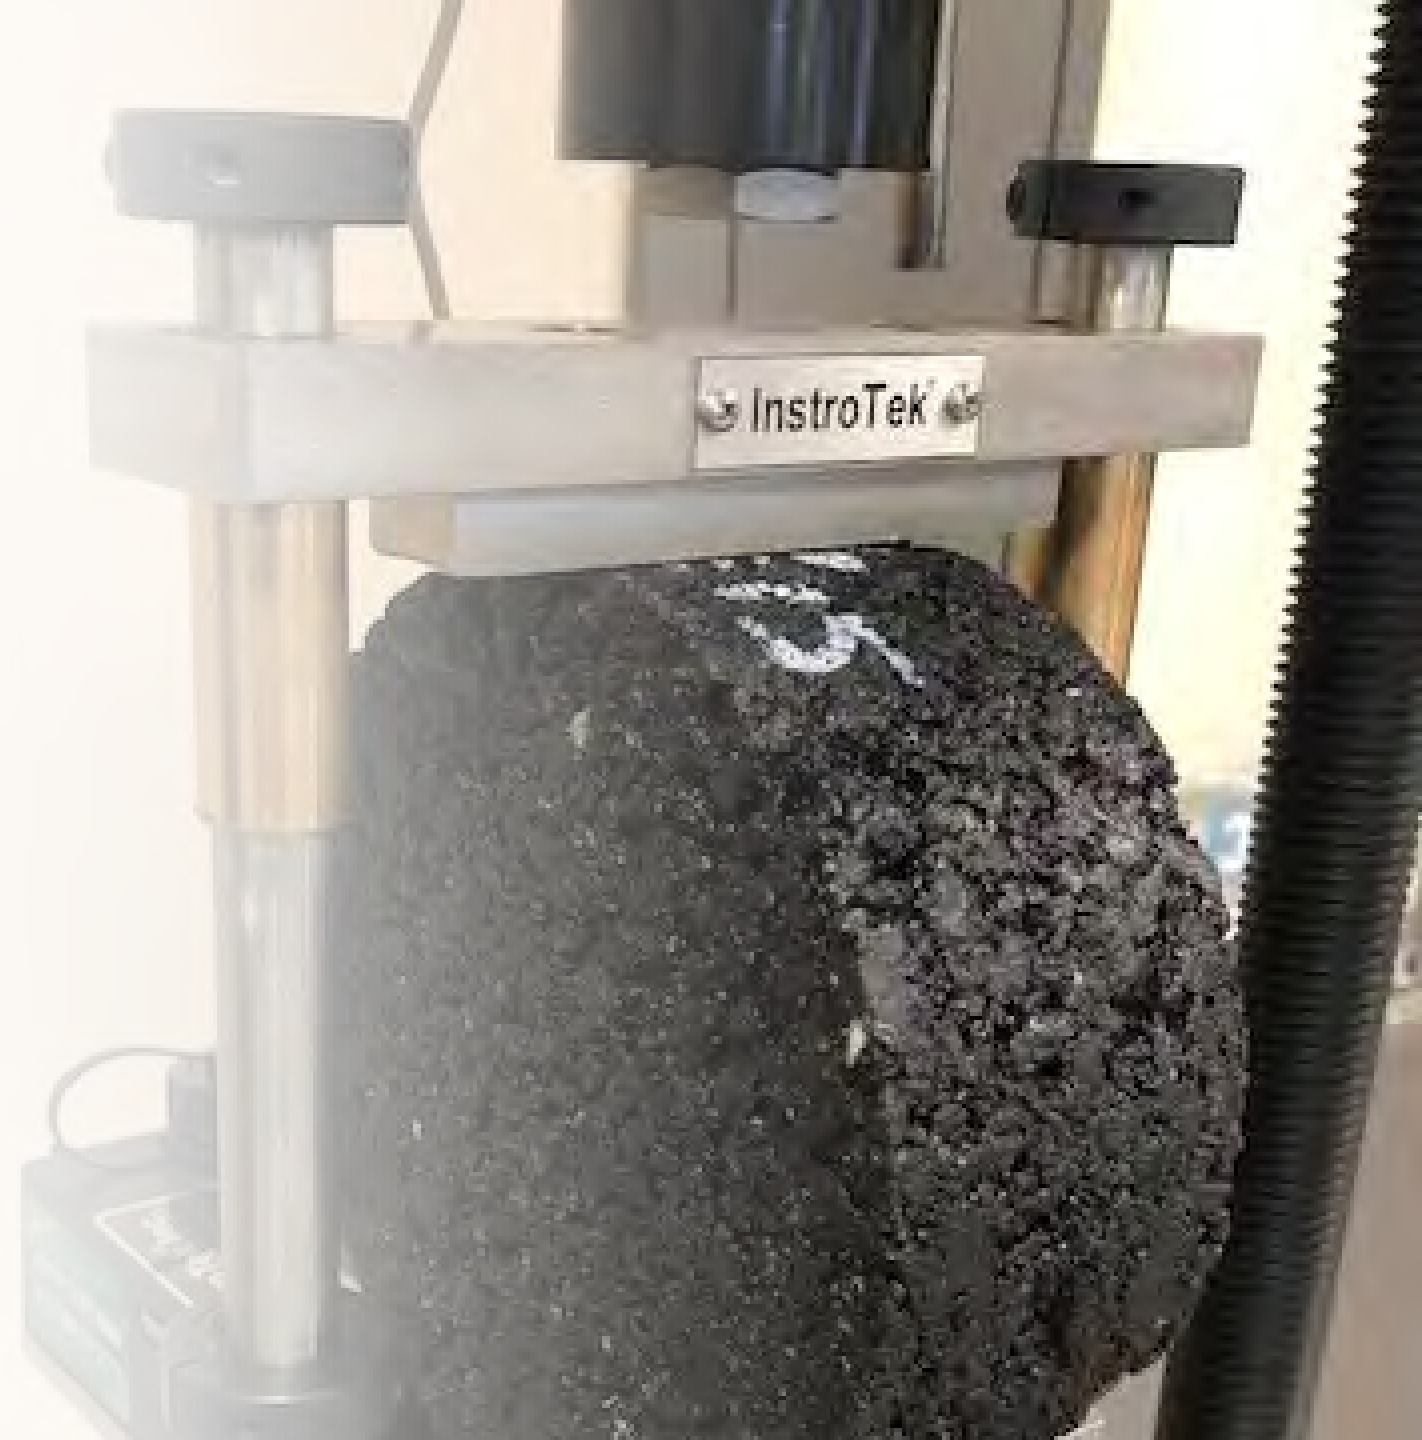
IDEAL-CT: Collaborative Testing

0.5% Anti-Strip

- ❑ No significant differences in rutting between specimens with or without anti-strip additives.
- ❑ Rutting was minimally affected by various terminal binder liquids.
- ❑ CT Indices significantly decreased with the addition of chemical anti-strip additives. Crack resistance had greatly improved in specimens without anti-strip additives.
- ❑ CT Indices were significantly affected by source of liquid binder.

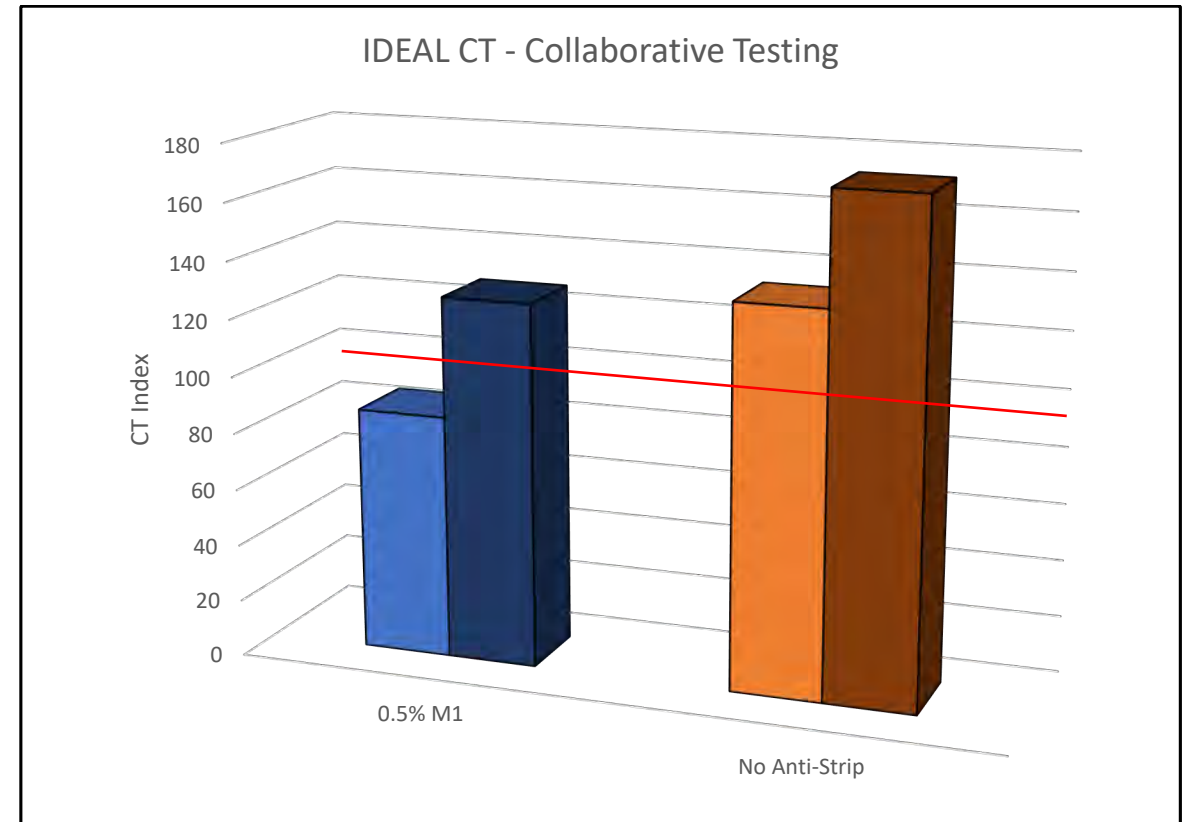
PTC Lab Sample : CT Index = **86**

Penn State Sample : CT Index = **128**

Without Anti-Strip

PTC Lab Sample : CT Index = **134**

Penn State Sample : CT Index = **173**

❖ Better crack resistance without anti-strip

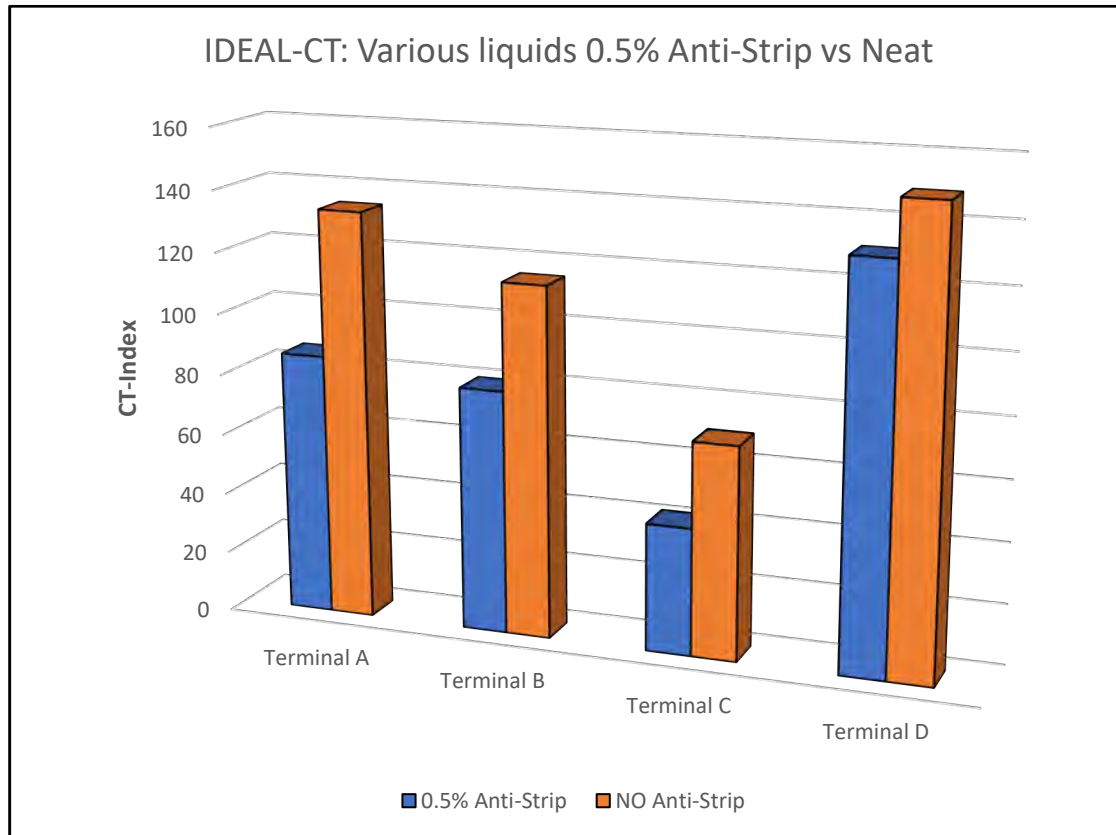
IDEAL-CT: PTC Lab Various 64E-22 w/wo Anti-strip

0.5% Anti-Strip

WO Anti-Strip

Terminal "A"

86

134

Terminal "B"

80

115

Terminal "C"

42

70

Terminal "D"

131

149

Avg. CT Index

85

117

❖ Significant difference

❖ Better crack resistance without anti-strip
